**REMOVAL PROGRAM
AFTER ACTION REPORT
FOR THE
OAK STREET REMOVAL SITE
TAUNTON, BRISTOL COUNTY, MASSACHUSETTS
5 AUGUST 2002 THROUGH 10 JANUARY 2003**

U.S. Environmental Protection Agency
Region I
Emergency Planning and Response Branch
One Congress Street, Suite 1100
Boston, MA 02114-2023

Weston Solutions, Inc.
Region I
Superfund Technical Assessment and Response Team 2000
37 Upton Drive
Wilmington, MA 01887

March 2003

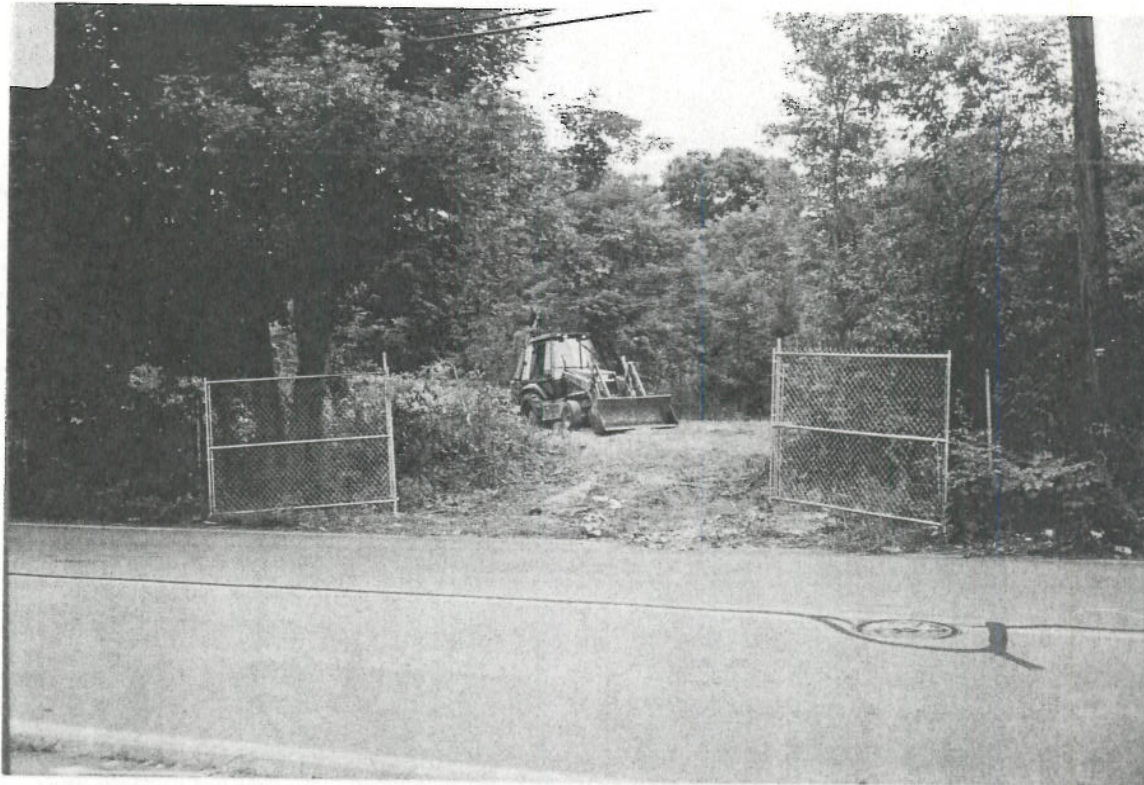
FRAME NUMBER: 00 **DATE:** 6 August 2002

SCENE: View of the entrance to the site. Photograph taken facing north.

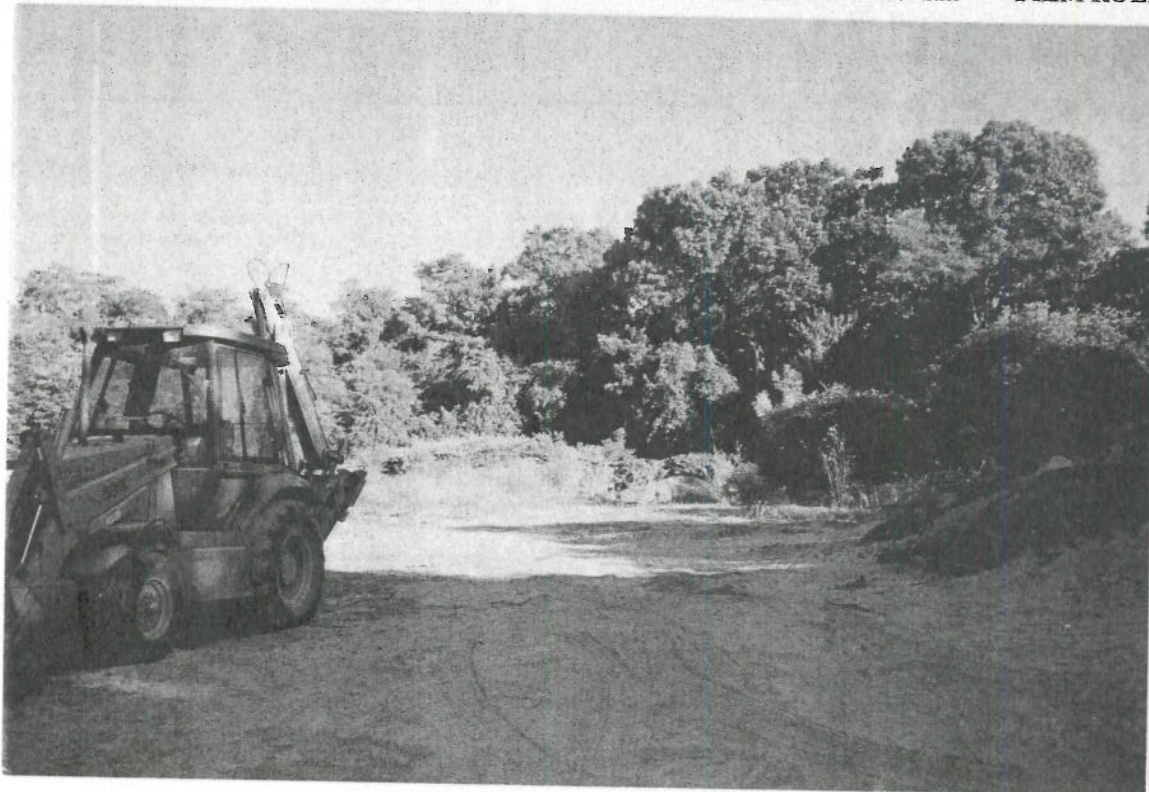
FRAME NUMBER: 01 **DATE:** 8 August 2002

SCENE: View of site conditions during site clearing activities. Photograph taken facing northwest.

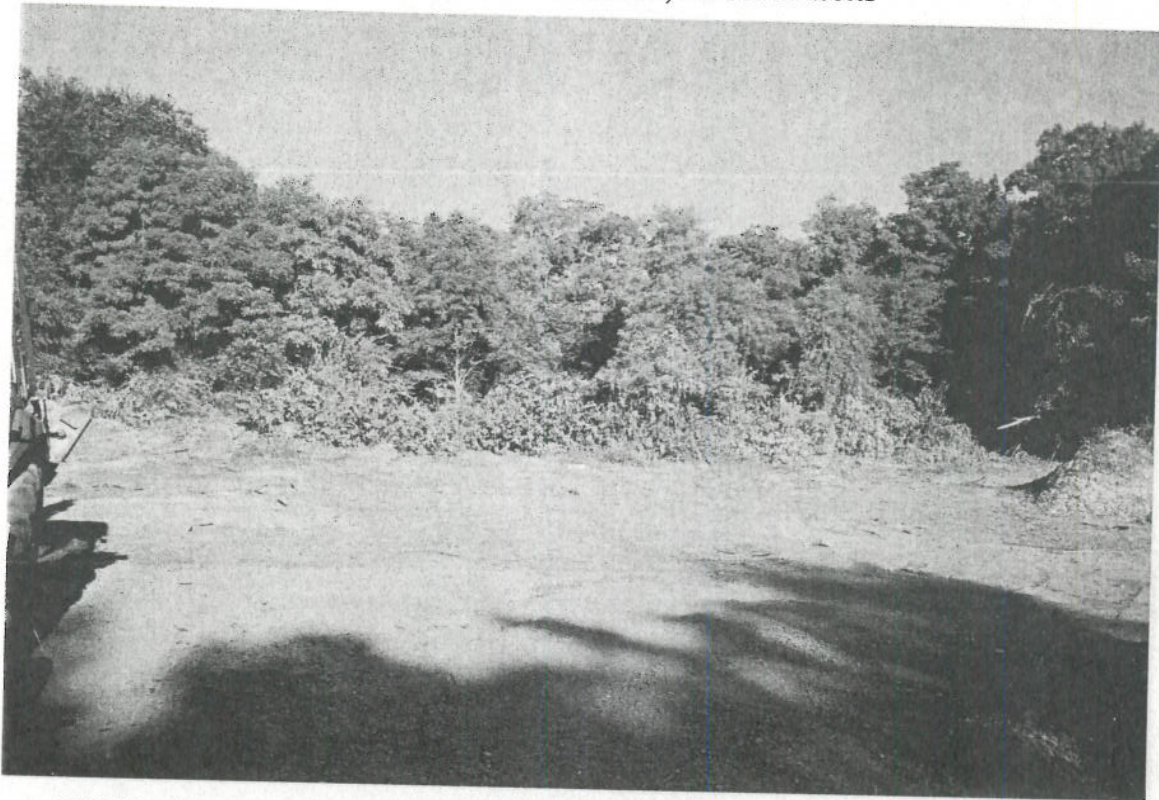
SCENE: View of the site after clearing and grubbing activities were completed. Photograph taken facing west.
FRAME NUMBER: 06 **DATE:** 21 August 2002 **TIME:** 0802 **SKY CONDITION:** Clear
PHOTOGRAPH BY: Alysha Thompson **WITNESS(ES):** none
CAMERA: Olympus **SETTING:** Automatic **FILM TYPE:** 35-mm **FILM ROLL:** 5245

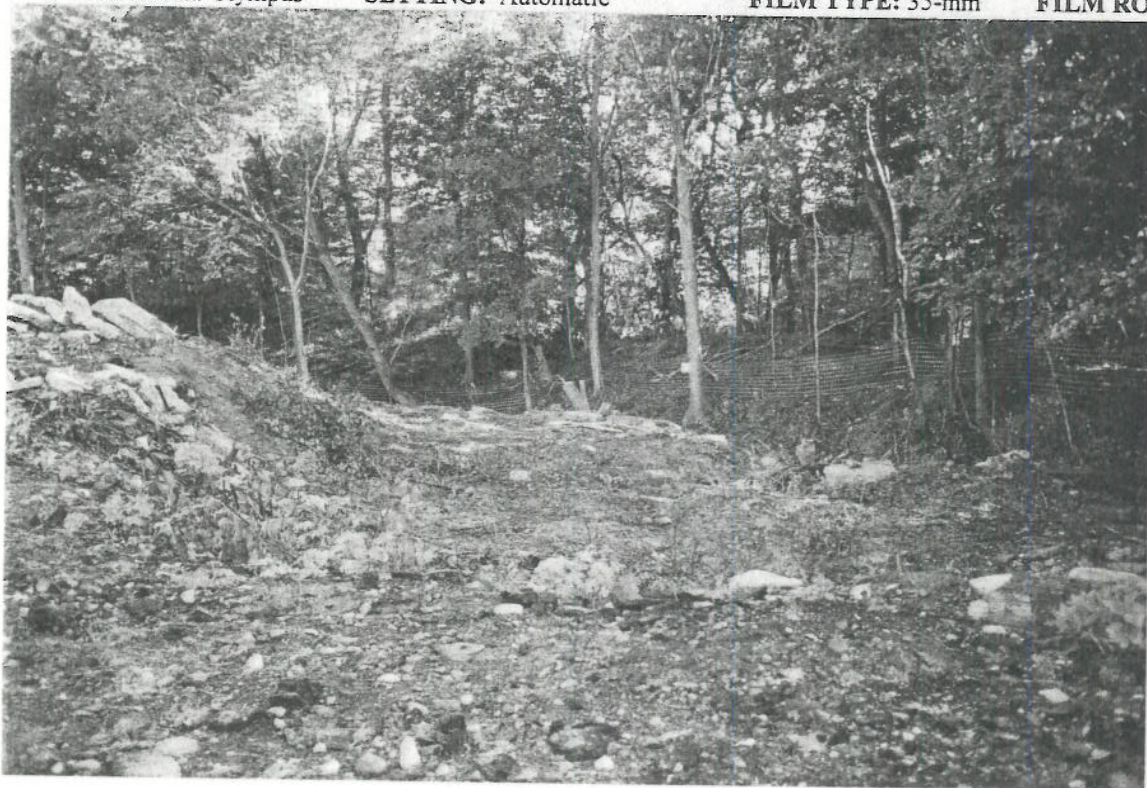
SCENE: View of the ravine along the eastern portion of the site that was the origin of the first grid section to be excavated. Photograph taken facing north.
FRAME NUMBER: 07 **DATE:** 18 September 2002 **TIME:** 0846 **SKY CONDITION:** Clear
PHOTOGRAPH BY: Alysha Thompson **WITNESS(ES):** none
CAMERA: Olympus **SETTING:** Automatic **FILM TYPE:** 35-mm **FILM ROLL:** 5245

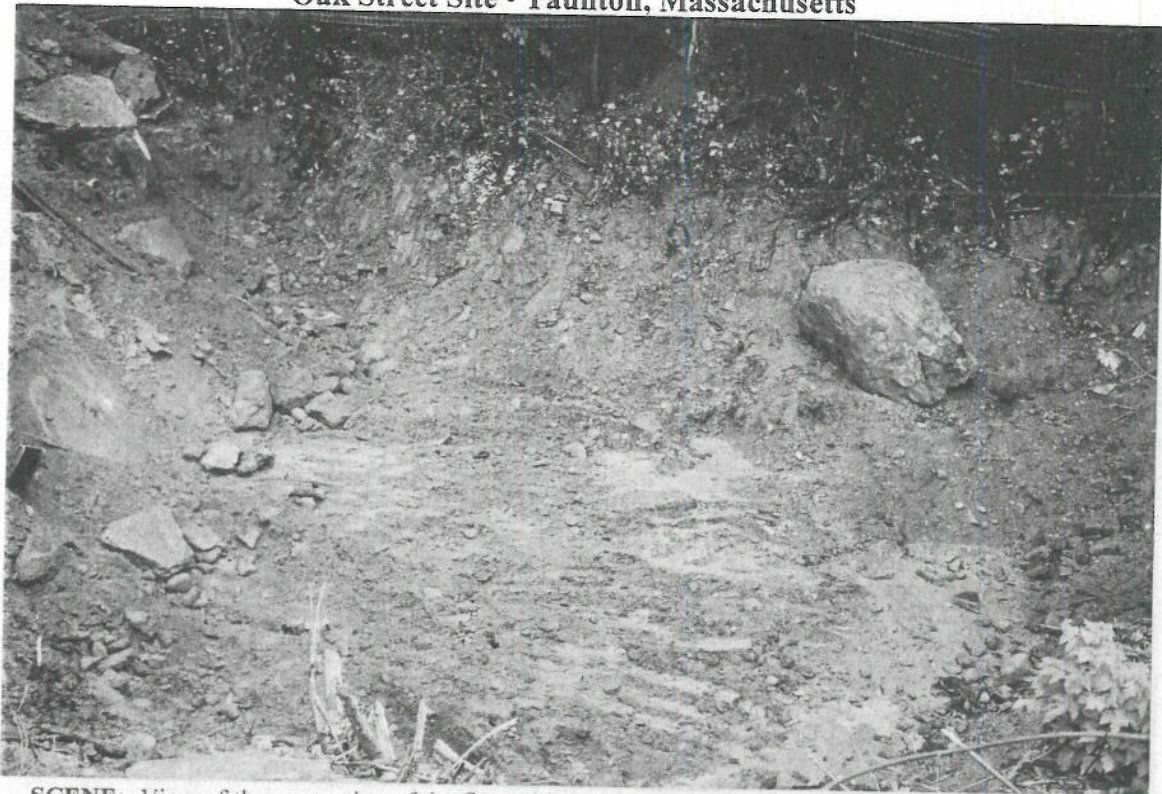
FRAME NUMBER: 11 **DATE:** 23 September 2002

SCENE: View of the excavation of the first grid section on the east side of the site prior to the area being backfilled. Photograph taken facing west.

ERRS personnel arrived on site to continue to excavate the first 25-foot grid section located on the east side of the property. Air monitoring was performed daily by START personnel for each day during which intrusive activities were conducted. Excavation activities were conducted individually, excavating each grid section until natural ground level was reached or until all drums were removed. If air monitoring and direct observation indicated the absence of contamination, the grid section was backfilled using the soil that was originally excavated from that grid section. Each grid section was backfilled prior to commencement of excavation activities of the adjacent grid section. Drums encountered during excavation were staged on polyethylene sheeting for subsequent sampling and overpacking by ERRS personnel.

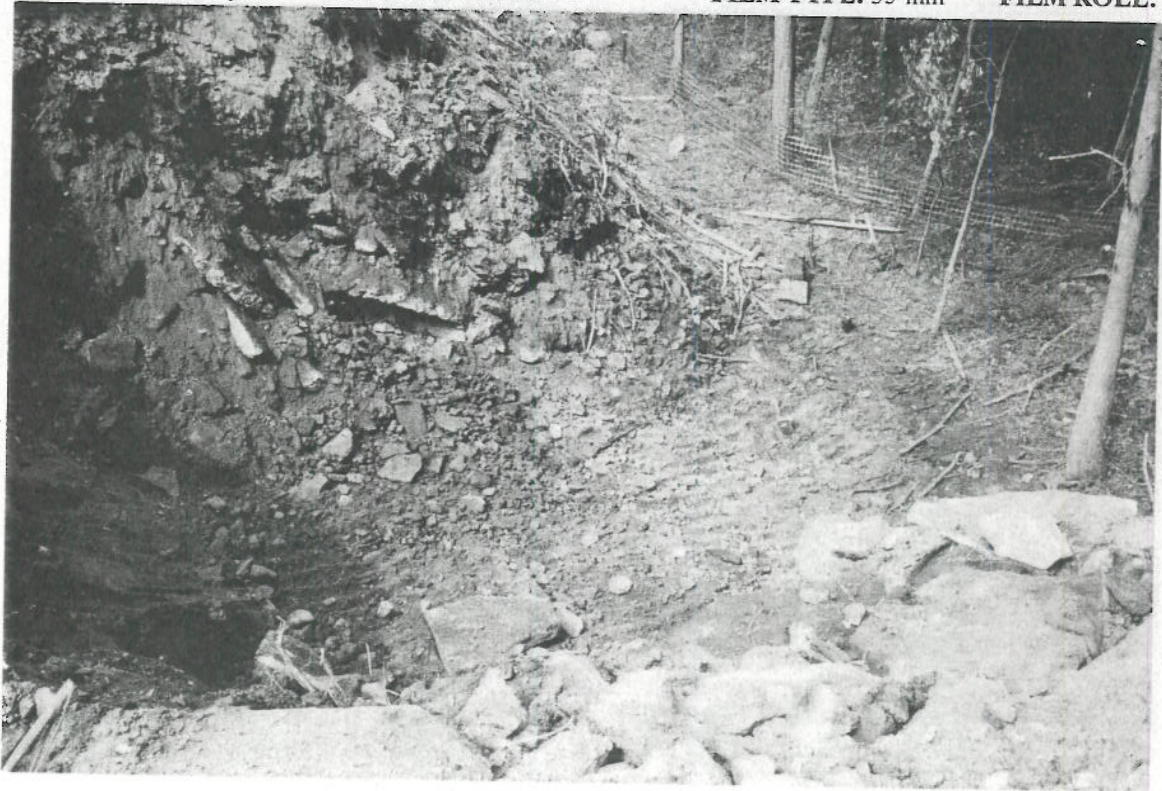
FRAME NUMBER: 13 **DATE:** 30 September 2002

SCENE: View of the excavation of the second grid section of excavation at original grade. Photograph taken facing east.

ERRS personnel continued excavation activities. The first three grid sections along the eastern perimeter of the site were excavated to natural ground level and subsequently backfilled. No drums were encountered.

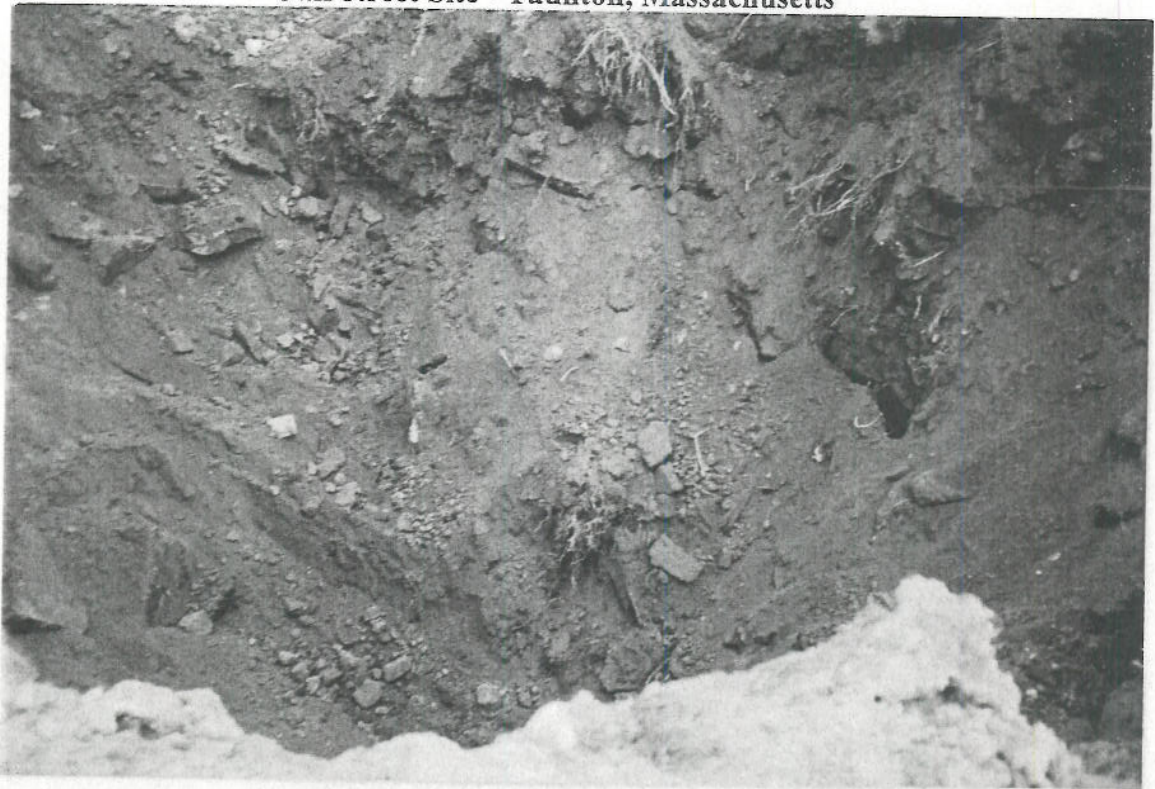
SCENE: View of the excavation of the third grid section at original grade. Photograph taken facing northeast.
FRAME NUMBER: 17 **DATE:** 7 October 2002 **TIME:** 1513 **SKY CONDITION:** Overcast
PHOTOGRAPH BY: Alysha Thompson **WITNESS(ES):** none
CAMERA: Olympus **SETTING:** Automatic **FILM TYPE:** 35-mm **FILM ROLL:** 5245

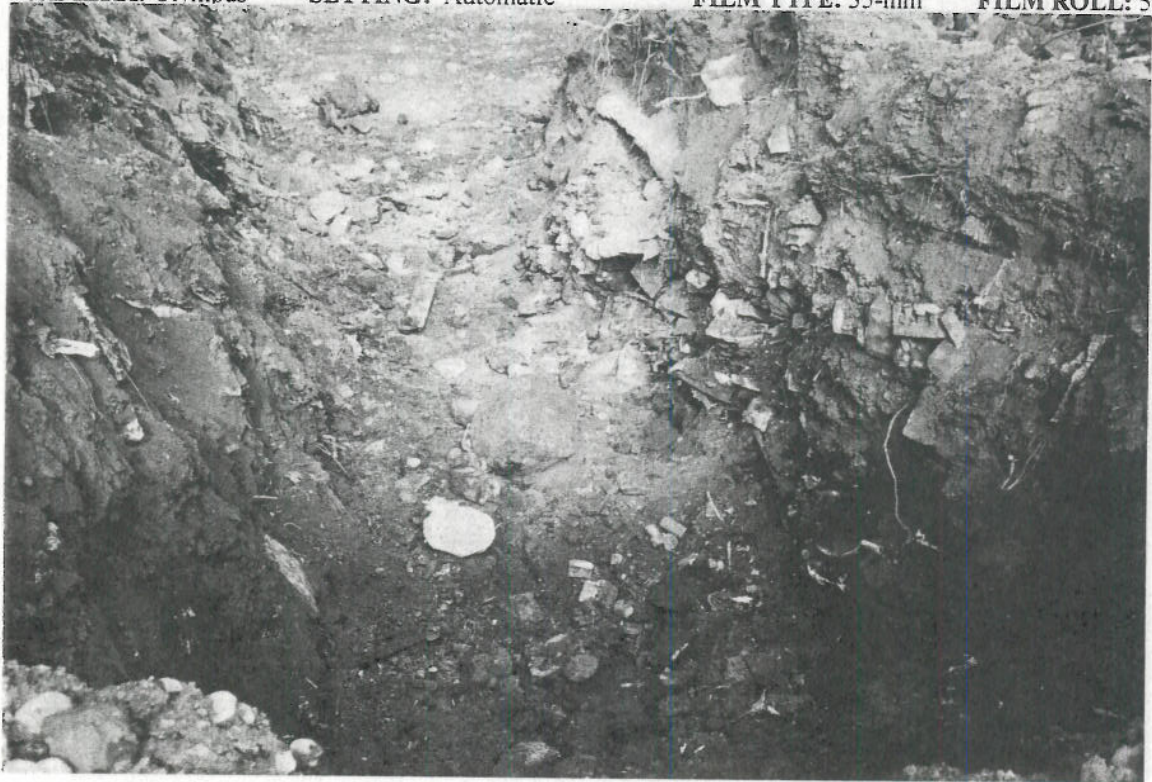
SCENE: View of the excavation of the first quarter of the fourth grid section to original grade. Photograph taken facing north.
FRAME NUMBER: 22 **DATE:** 28 October 2002 **TIME:** 1149 **SKY CONDITION:** Clear
PHOTOGRAPH BY: Alysha Thompson **WITNESS(ES):** none
CAMERA: Olympus **SETTING:** Automatic **FILM TYPE:** 35-mm **FILM ROLL:** 5245

ERRS personnel continued excavation activities on the fourth grid section. Once excavation activities were completed on the fourth grid section, backfilling occurred. No drums were encountered.

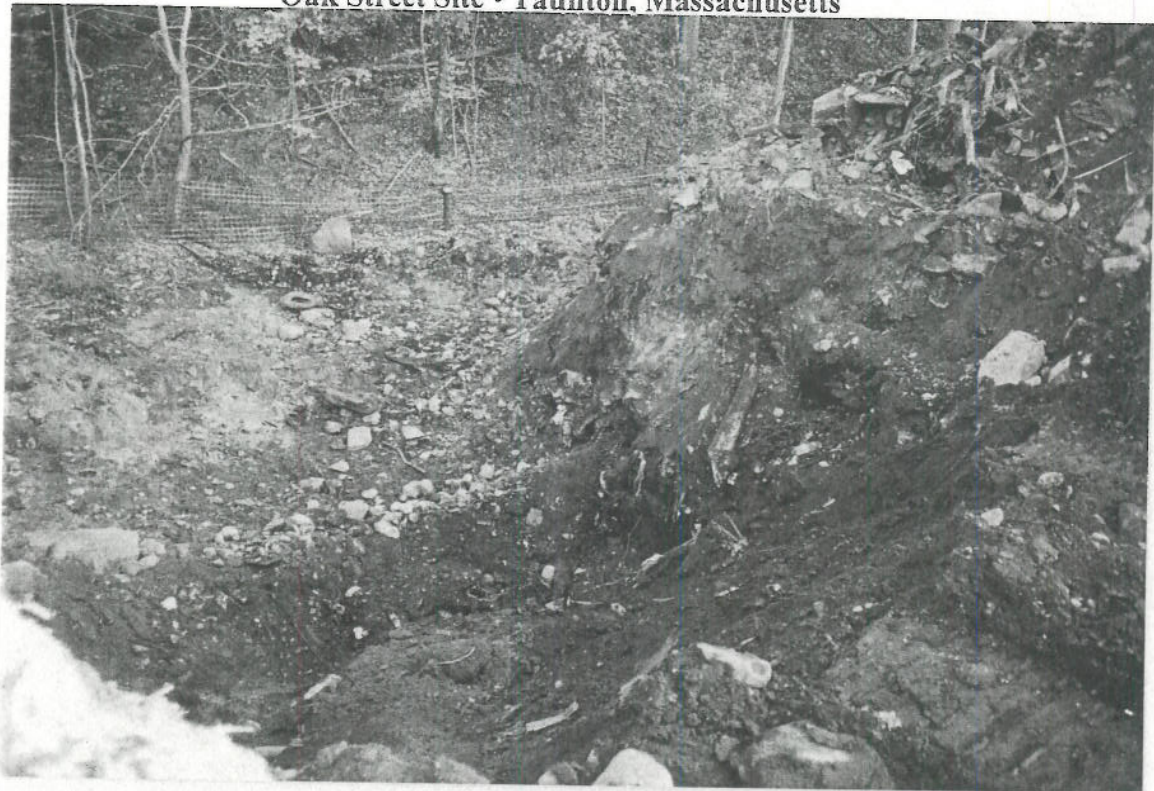
FRAME NUMBER: 24 **DATE:** 1 November 2002

SCENE: View of the excavation of the first quarter of the fifth grid section to original grade. Photograph taken facing northeast.

ERRS personnel continued excavation activities. The fifth grid section was excavated and two drums were encountered and removed. The drums were labeled D001 and D002 by ERRS personnel.

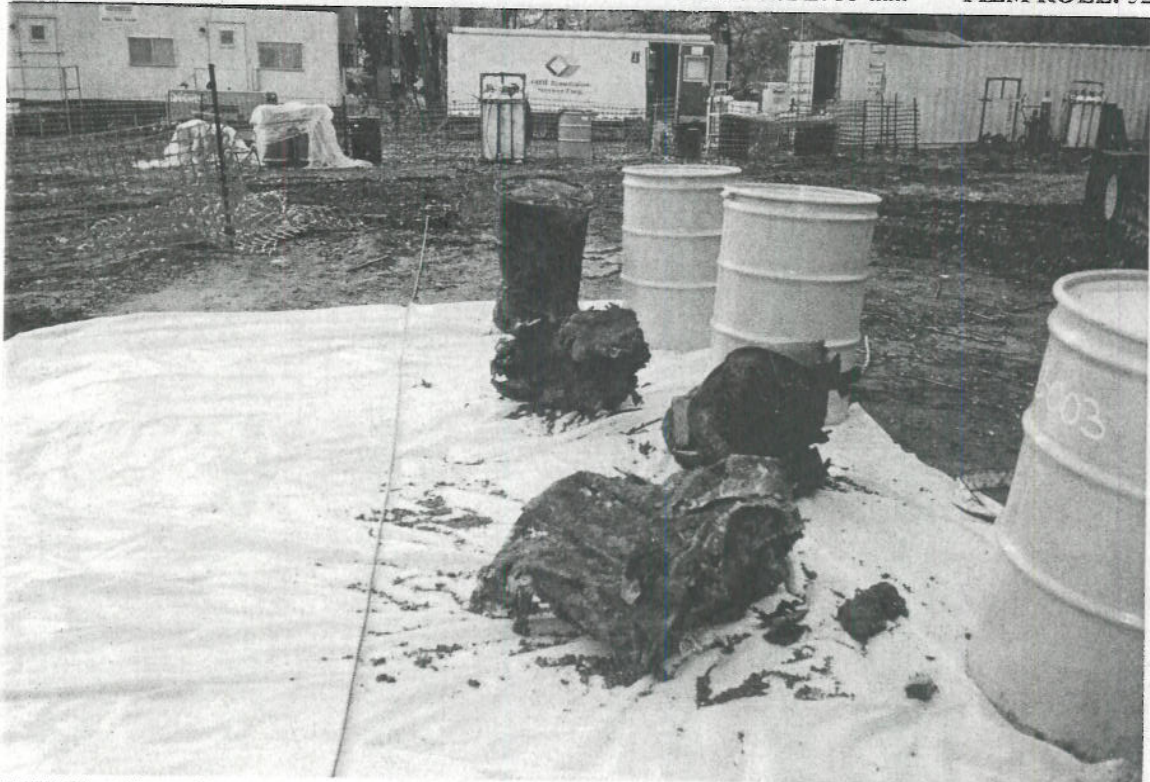
FRAME NUMBER: 01 **DATE:** 12 November 2002

SCENE: View of the drums excavated from the fifth grid section and overpacks drums. Photograph taken facing southeast.

ERRS personnel continued excavation activities on the fifth grid section. Thirty-one drums were encountered, removed, and labeled D006 through D035.

On 15 November 2002, drums D006 through D035 were sampled and overpacked by ERRS personnel.

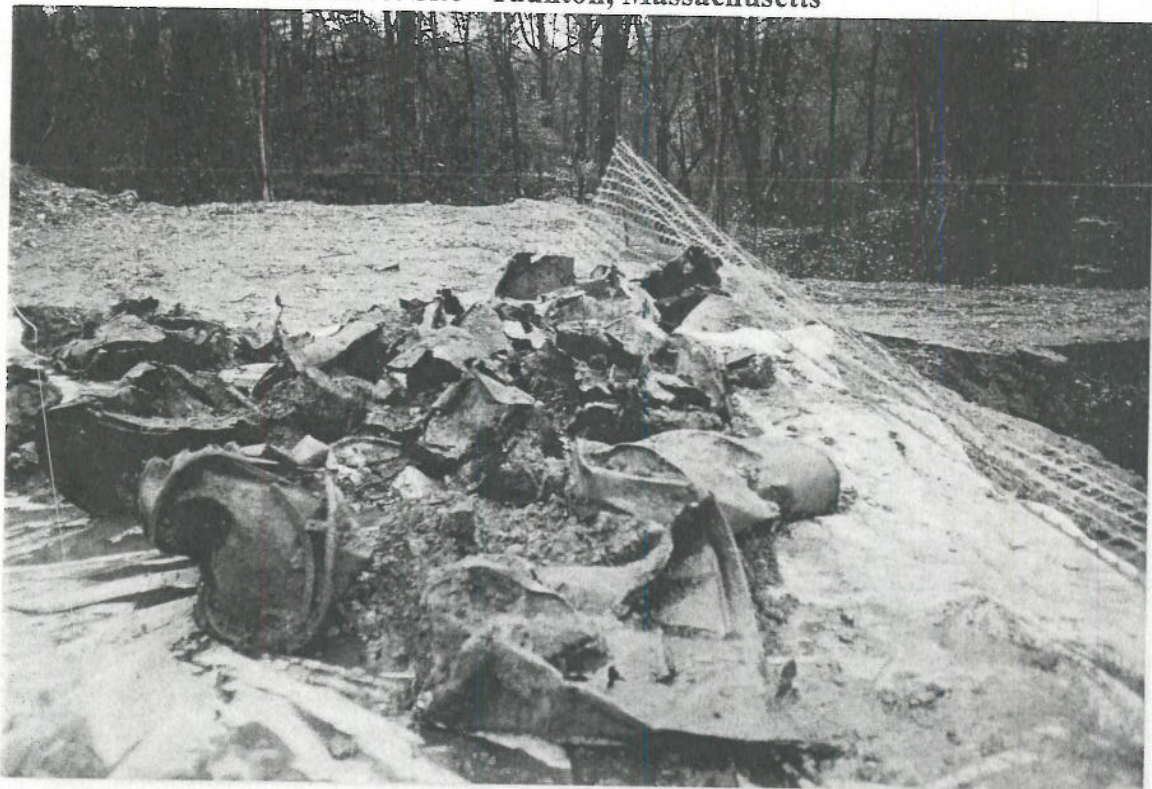
FRAME NUMBER: 02 **DATE:** 13 November 2002

SCENE: View of the drums excavated from the fifth grid section prior to being overpacked. Photograph taken facing northwest.

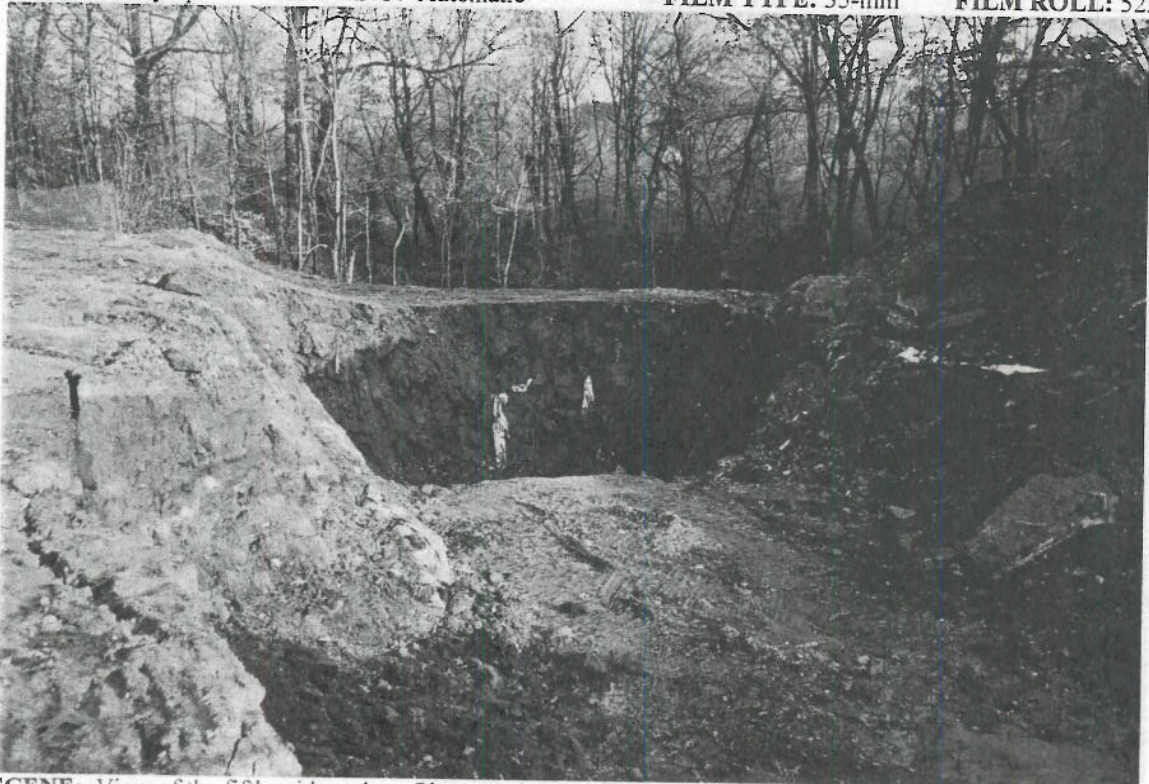
FRAME NUMBER: 04 **DATE:** 18 November 2002

SCENE: View of the fifth grid section. Photograph taken facing north.

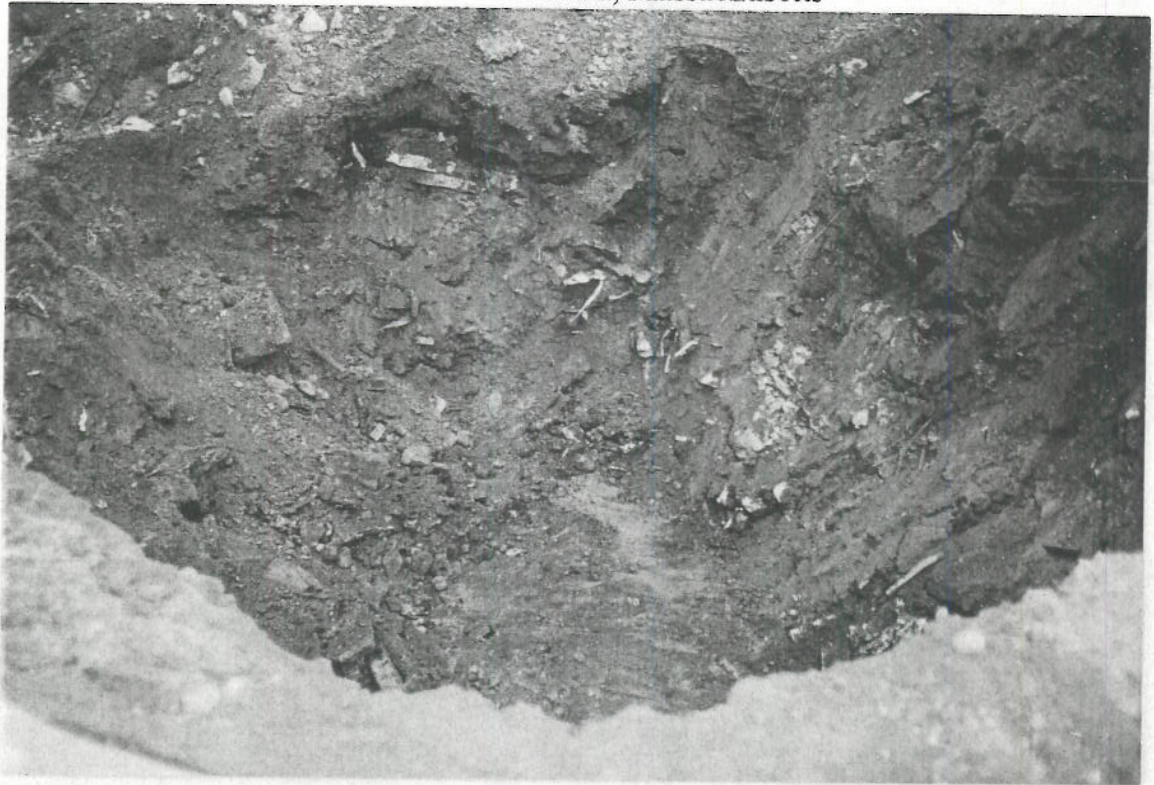
SCENE: View of the bottom of the fifth grid section. Photograph taken facing south.
FRAME NUMBER: 10 **DATE:** 21 November 2002 **TIME:** 1550 **SKY CONDITION:** Overcast
PHOTOGRAPH BY: Mandy Butterworth **WITNESS(ES):** none
CAMERA: Olympus **SETTING:** Automatic **FILM TYPE:** 35-mm **FILM ROLL:** 5236

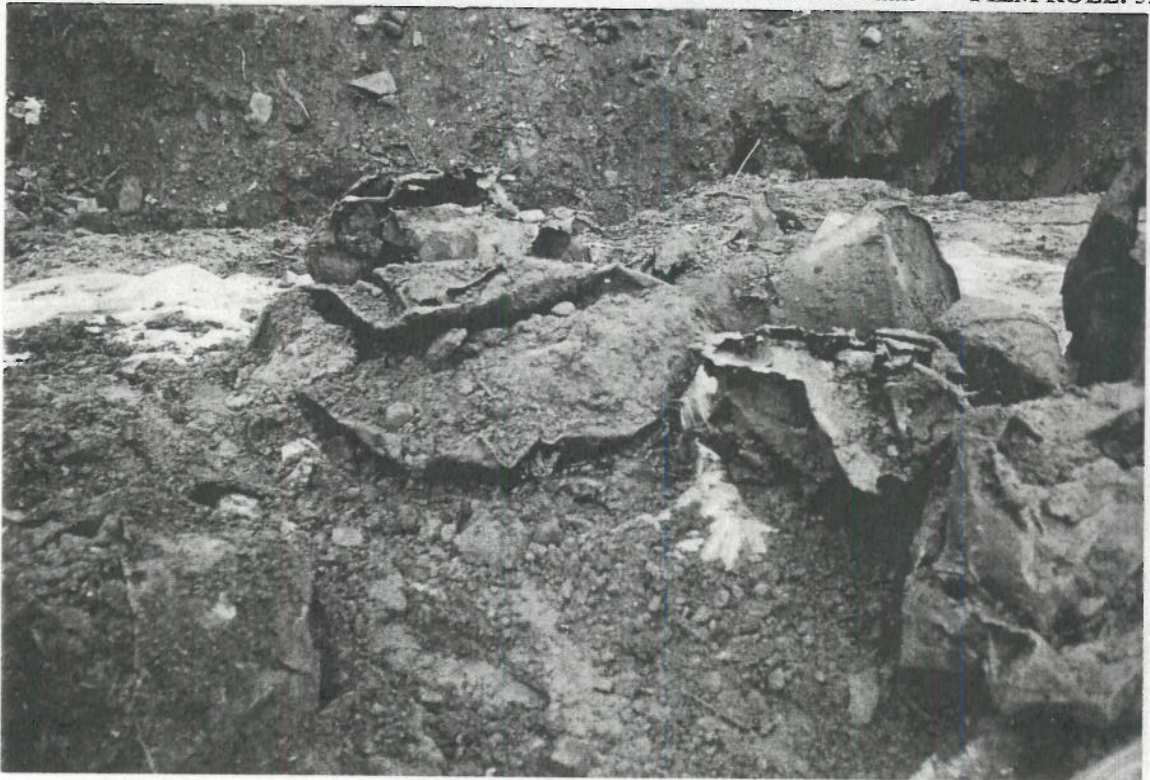
SCENE: View of drums with viscous product. Photograph taken facing east.
FRAME NUMBER: 13 **DATE:** 22 November 2002 **TIME:** 1318 **SKY CONDITION:** Overcast
PHOTOGRAPH BY: Mandy Butterworth **WITNESS(ES):** none
CAMERA: Olympus **SETTING:** Automatic **FILM TYPE:** 35-mm **FILM ROLL:** 523

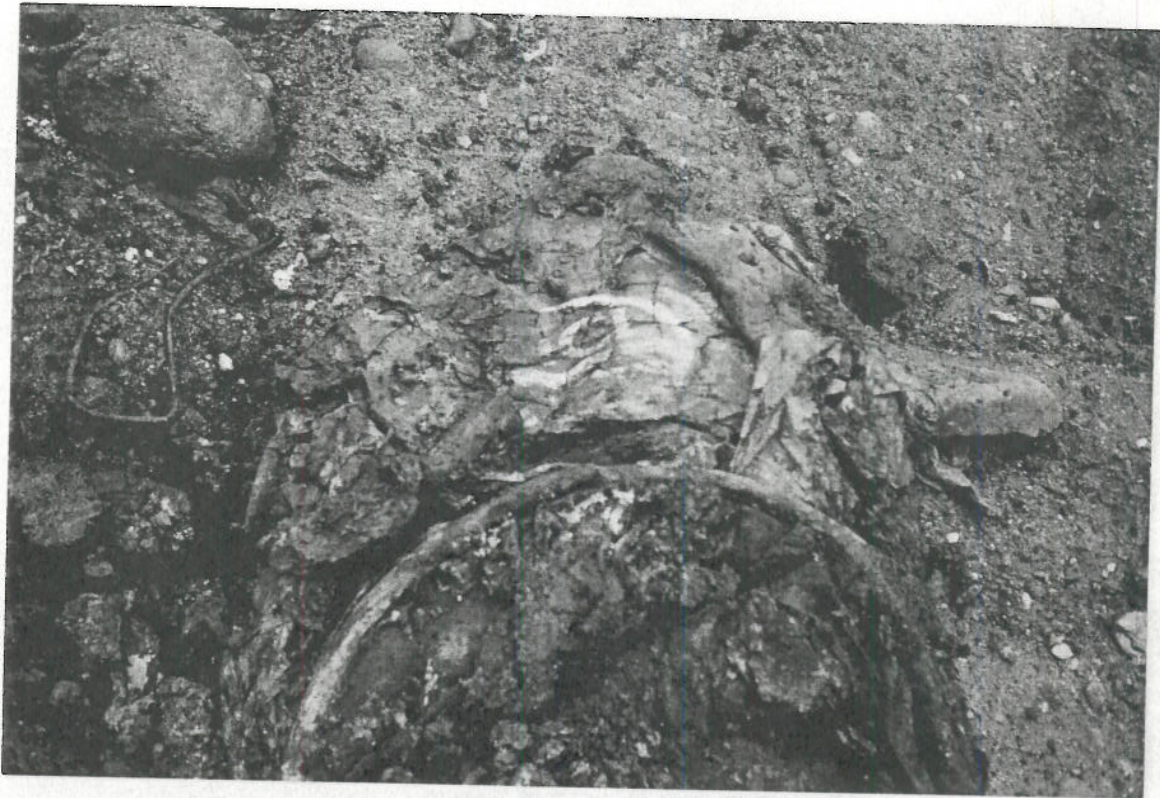
FRAME NUMBER: 20 **DATE:** 12 December 2002

SCENE: View of a fiber drum with a red label and white letters reading "ICI".

On 20 December 2002, 10 drums were encountered, removed, and labeled D067 through D076, sampled and overpacked by ERRS personnel. An ICI label was observed on drum D070.

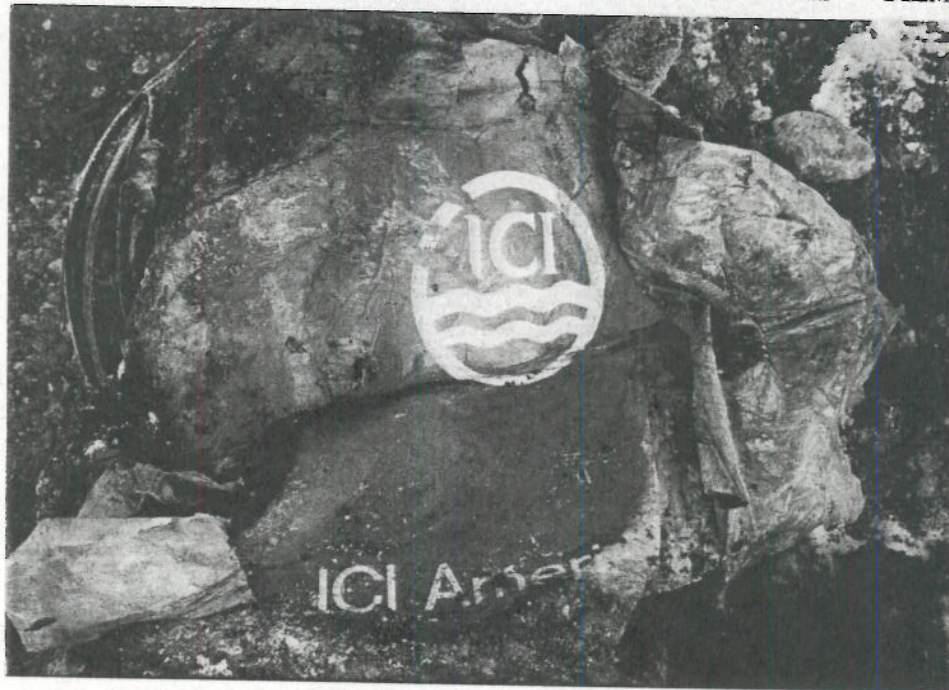
FRAME NUMBER: 1A **DATE:** 18 December 2002

SCENE: View of the second fiber drum with a red label and white letters reading "ICI".
